**BILATERAL PERI-PROSTHETIC FRACTURES AFTER TOTAL
KNEE ARTHROPLASTY IN A PATIENT WITH SEVERE
RHEUMATOID ARTHRITIS. A CASE REPORT AND MANAGEMENT
APPROACH**

The following case report describes the management of a bilateral total knee replacement with asymmetrical periprosthetic fractures, the right was supracondylar type 1A according to Kim's [12] classification and the left was tibial fracture type IV according to Felix's [13] classification type 4 according to Mayo classification.

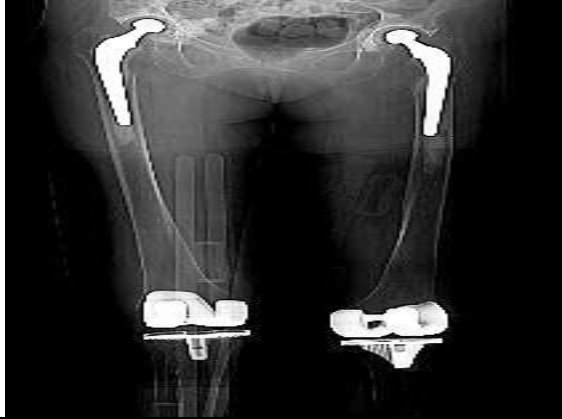
Figure 1. CT scanogram, performed prior to injury for leg length. Shows bilateral THRs and TKRs.

A 71 year old female presented with a past medical history of severe Rheumatoid arthritis, on Methotrexate treatment and previous bilateral total knee and hip replacements (figure-1). Normally, she mobilised independently when at home and used a tripod on occasions when in pain or mobilising outside. The patient tripped and fell forwards, landing on her knees. She presented to accident and emergency department with a painful, swollen and bruised right knee. The left knee was tender over the distal femur. X rays confirmed bilateral fractures, both were closed and neurovascularly intact, a subsequent CT scan confirmed a minimally displaced and well aligned left supracondylar fracture (figure-2).

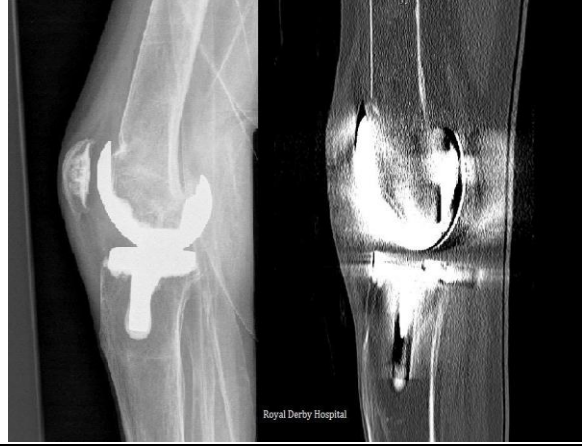
Figure 2. left supracondylar femoral fracture:

This current left sided fracture was managed conservatively using a knee hinge brace and the patient was kept non weight bearing on the left leg.

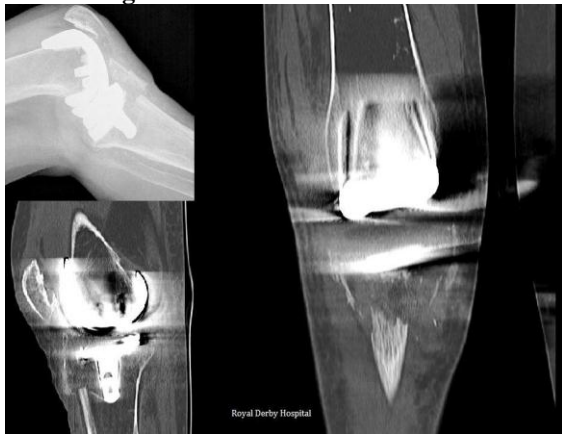
Figure 3. Proximal tibia fracture

Unfortunately the right side was more complicated with a tibial collapse and avulsion of the tibial tuberosity (figure-3).

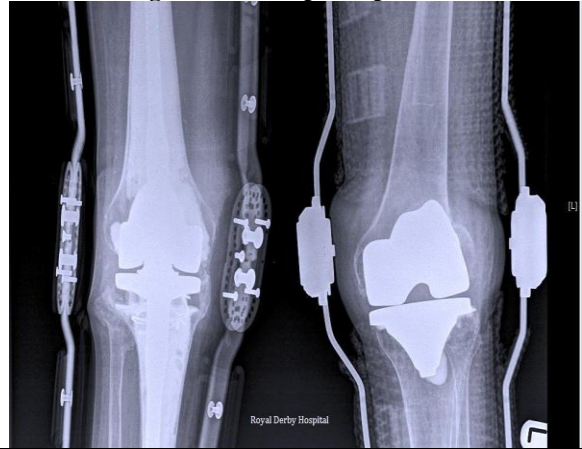
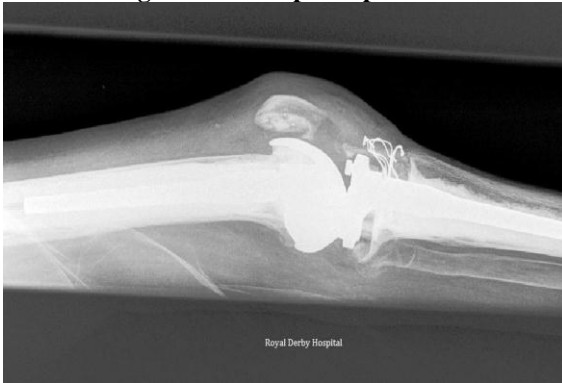
Figure 4 and 5. post-operative

As the right side was a first generation Genesis TKR, this had to be revised to a modular link hinge prosthesis. The tibial tubercle aspect of the fracture was treated similar to a patellar tendon rupture as the bone piece was relatively small and not suitable for fixation. The patient was allowed to bear weight on this leg from the first day post-op. (Figure-4 and 5)

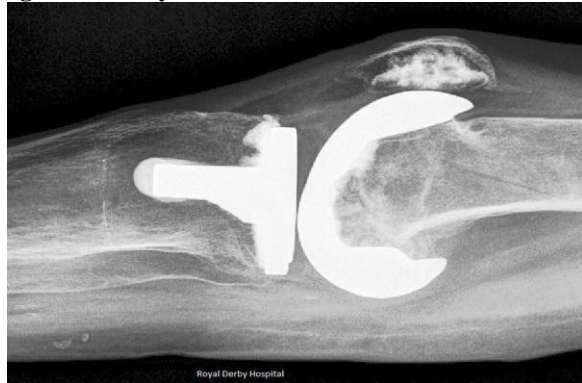
Figure 6. X-rays after 9 weeks show callus formation

Attention then turned to rehabilitation which involved physiotherapy, bed care and DVT prophylaxis. The patient then spent a total of four weeks in hospital prior to discharge, she was then followed up in the out-patient follow-up clinic to enable monitoring of wound healing, callus formation, extensor mechanism function and progress of mobility. Nine weeks following surgery the patient was allowed to fully weight bear out of brace on the right side, on the left side the hinged knee brace was unlocked from 0 to 90 degrees and partial weight-bearing was permitted. The x-rays confirmed callus formation on the left side (fig-6). The patient was followed up again after 6 weeks with a satisfactory outcome.
