## FORENSIC INVESTIGATION OF AN AMBUSH CASE

**Ajitesh Pal\* and H.K. Pratihari**

Tripura State Forensic Science Laboratory, Agartala –799015, Tripura, India.

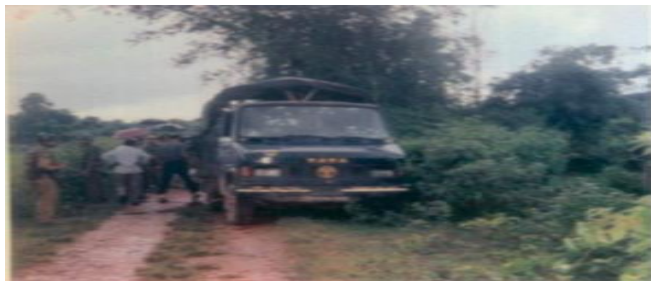
**Figure 1. The vehicle carrying TSR jawans ambushed and killed**

The affected vehicle and the wind glass having bullet holes pattern are shown in the figures 1 and 2. The blood spatters on the body of the vehicle and the deceased jawans are shown in the figures 3 and 4 respectively. The recovered fired cartridge cases (43) and some of their firing pin marks viewed under ballistics comparison microscope (DMC, Leica, Germany) are shown in the figures 5 and 6. The fired cartridge cases have been examined and compared based on their individual and class

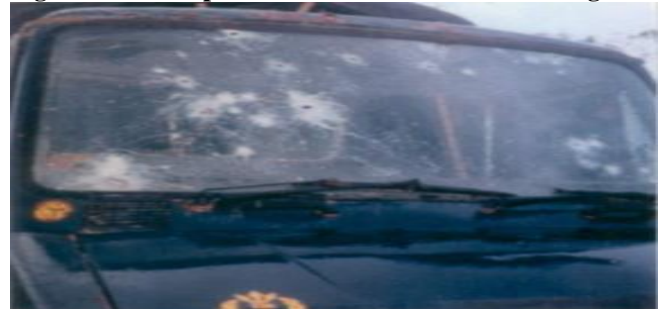
**Figure 2. Close up view of the bullet holes on wind glass**

- The fracture pattern on wind glass and body of the truck was possible by high velocity projectiles.
- The tyre/tube of the ambushed vehicle was found deflated with bullets to restrict movement.

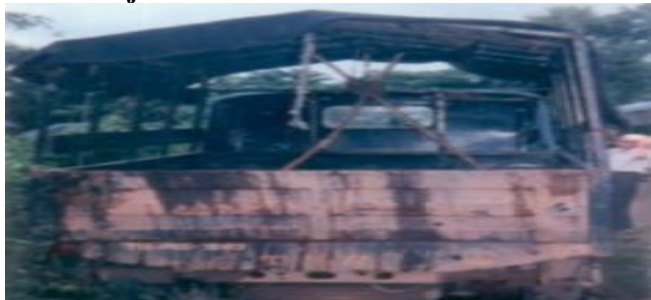
**Figure 3. Streaming of mixed blood stain pattern of the ambushed jawans on the back side of the vehicle**

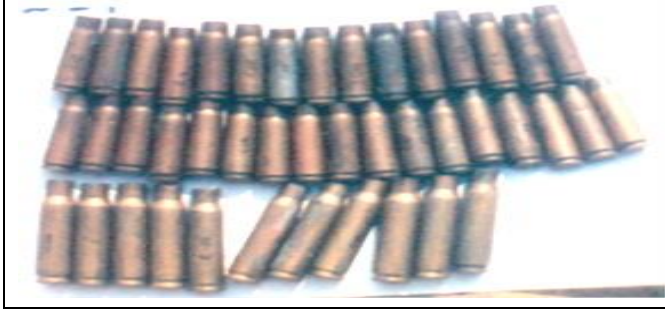
**Figure 5. 43 fired cartridge cases recovered from the ambushed area for generating data bank of firearm signature.**

- (i) On the basis of the physical examination of 43 rifle cartridge cases, 32 cartridge cases were identified as 7.62×39mm AK-47 rifle cartridge cases, 11 cartridge cases as 7.62×51mm self loading rifle (SLR) cartridge cases.
- (ii) On the basis of the factory codes present on the head stamp markings of 43 numbers rifle cartridge cases examined with the reference available in the ballistics literature, the country of origin of the fired rifle cartridge cases have been identified as follows:
- (iii) On thorough examination and inter-comparison of the class and individual characteristic marks present on 43 crime cartridge cases under comparison microscope, it was concluded that 9 firearms were used by militants to fire 43 number rifle cartridge cases

Factory codes on head stamps	Number of cartridge cases	Type of cartridge cases	Country of origin
31,61,71	28	7.62×39mm	China
539	01	7.62×39mm	Soviet Union
322	02	7.62×39mm	Romania
VPT	01	7.62×39mm	Finland
OFV	10	7.62×51mm	India
Markings in Burmese script	01	7.62×51mm	Burma

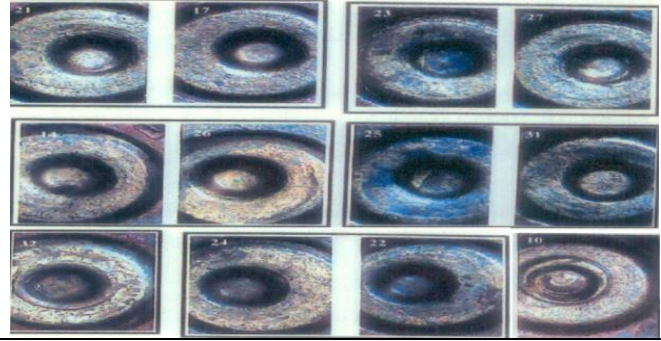
**Figure 6. Digital images of the firing pin marks of some of the cartridge cases collected from ambush area.**
